**WSDOT/WASHINGTON STATE FERRIES**

**Investigation into the Circumstances Surrounding the  
Damage to the Propulsion Drive Motor aboard the  
M/V WALLA WALLA on Nov. 4, 2012 while  
Undergoing Maintenance at Eagle Harbor  
Maintenance Facility**

**2/25/2013**

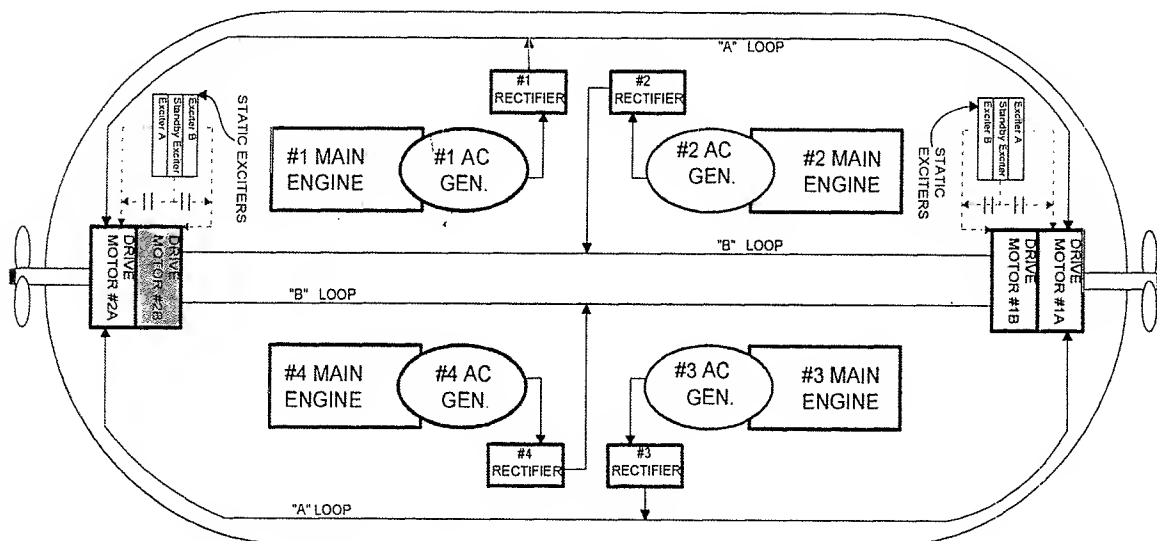
(Note that Diagram A depicts the loops and not the physical locations of the equipment). Each loop has two diesel generator sets supplying power to two drive motors wired in a series circuit. Each Loop (A Loop or B Loop) powers two drive motors which are physically located at opposite ends of the vessel. Motor room #1 contains drive motors #1A and #1B, and motor room #2 contains drive motors #2A and #2B. Normally the vessel will be operated with four main diesel generators running to supply power to all four drive motors. However, when deemed necessary by the operator, one to three alternators may be removed from service and the operation of the vessel can be continued at a reduced power level. The drive motors use direct current, commonly known as DC. The alternating current, commonly known as AC, is output from the main propulsion generators and is converted to DC through four separate rectifier units; from there, the DC is fed directly to each drive motor.

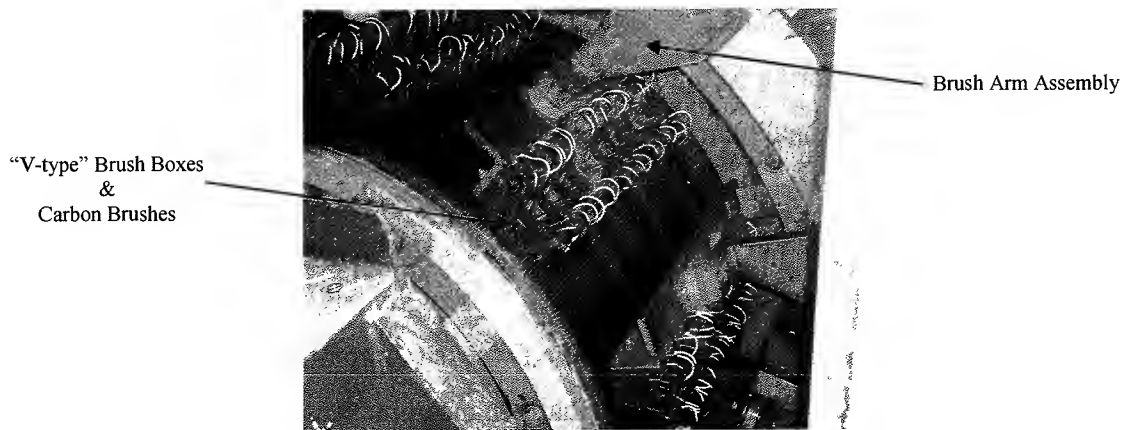
The drive motors on *Walla Walla* contain 12 brush arm assemblies, seen in Figure 1 below. Each brush arm has eight brush boxes mounted to it. These are double, V-type brush boxes

containing two oppositely angled brushes to accommodate the reversing nature of the motor. (See Attachment 11 and 12 for rigging configuration)

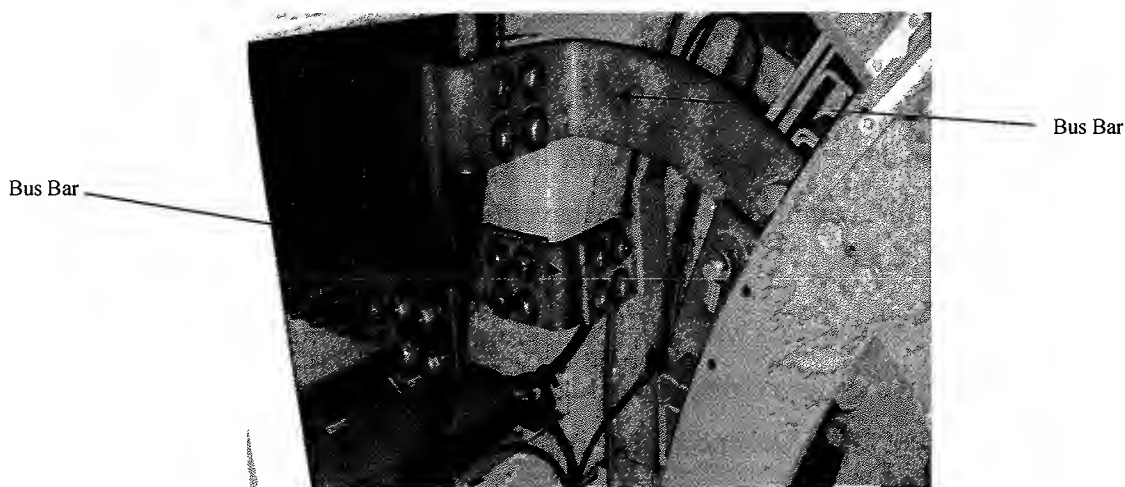
The second method, only to be used on an emergency basis as indicated from the original manufacturer's instruction manual (See Attachment 15), would be to reconfigure drive motor #1A's internal bus bars (See Attachment 16 and Attachment 17 ) so that its armature circuit was bypassed. A physical depiction of the bus bars is seen in Figure 2 below.

The reconfiguration work would have required all sources of power to A Loop to be removed first. Once these bus bars were reconfigured and the motor covers reinstalled, A Loop could be operated to perform the work of stoning drive motor #2B. The complete lock out of B Loop, including motor #1B and #2B, would still be required. Further, motor exciter #1A should also be locked out as had been done that day. The loop current that flowed through motor #2A to rotate motor #2B for stoning would also flow into motor #1A at the opposite end of the vessel. But that loop current would flow through the internal bypass shunt and not the motor armature and thus the commutator surface and brushes of motor #1A.

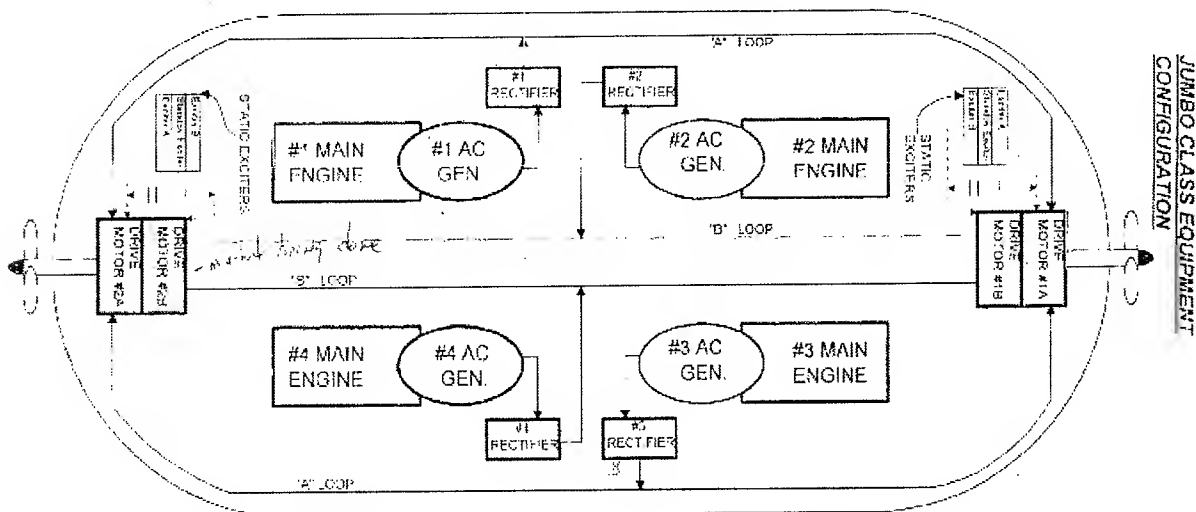
Figure 2

The figure above is being used to illustrate the electrical configuration of the Walla Walla. It is not intended for this diagram to depict the actual physical layout of the vessel. As shown in Figure 2, the Jumbo Class propulsion configuration (Walla Walla) is designed with two propulsion loops. The #3 Main Engine/Generator was providing power to the "A" loop, so that they could turn the #2B motor with the energized 2A motor that was assigned to the A loop. The brushes were all lifted on the 2B motor in order to hand stone the commutator.
